# Engineering Applications

# Chimney in Arouca

# Monastery of Salzedas (Portugal): Intervention in the cloister

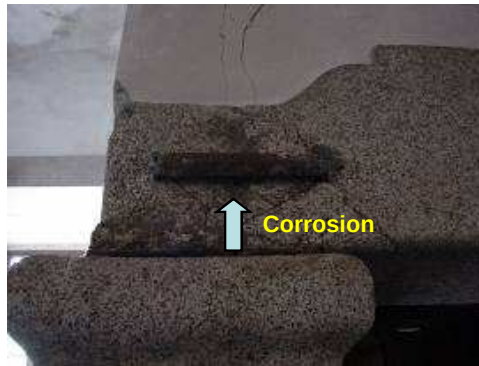
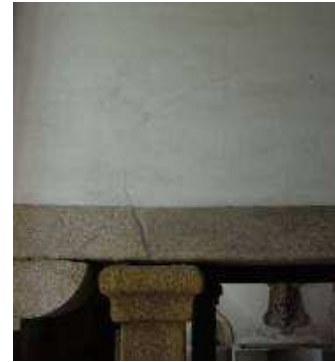
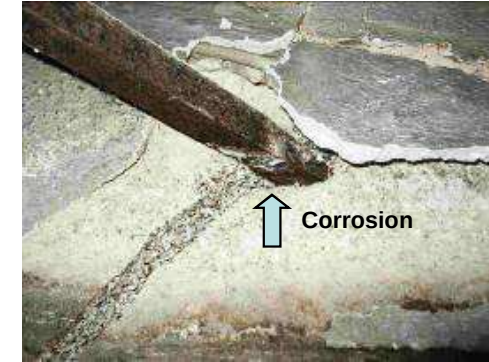
### Details of cracking in the supports

- ❑ Cracks in main lintel and one side lintel. Corrosion in the ties.
- ❑ Original building defects: asymmetric positioning of the main arch; possible lack of separation between arch and masonry infill; progressive cross-section reduction of the cracked side lintel.

- ❑ Chimney can be used for firing exceptionally.
- ❑ Corroded ties must be replaced by stainless steel. Other ties to be depassivated and fire protected.

- ❑ Two possible remedial measures: (a) glue stone with epoxy resin and inner strengthening, drill a long hole and insert post-tensioned bars; (b) lift chimney and replace stone by a new one

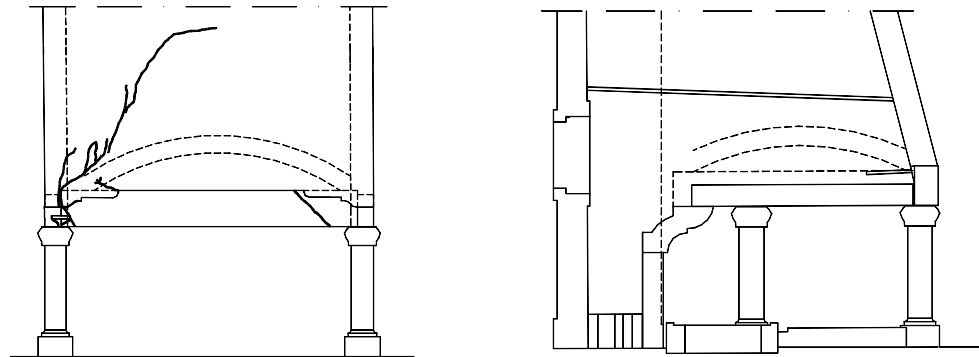
### Cracking in the front wall and left wall

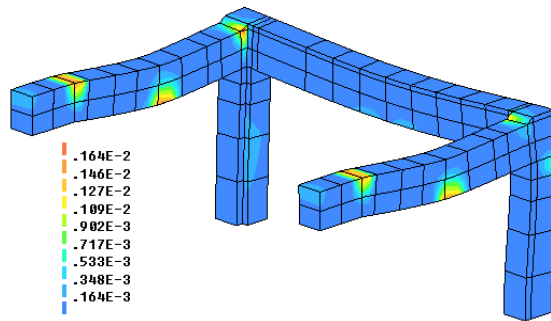
Cracking in transverse beams

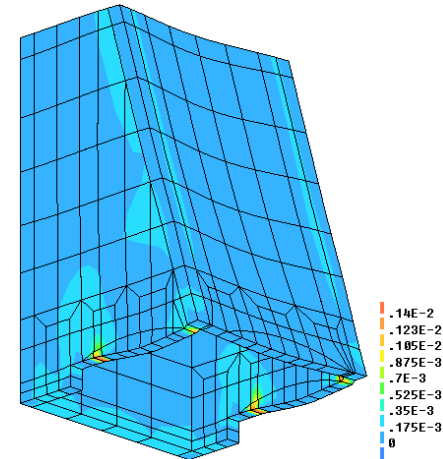
Cracking

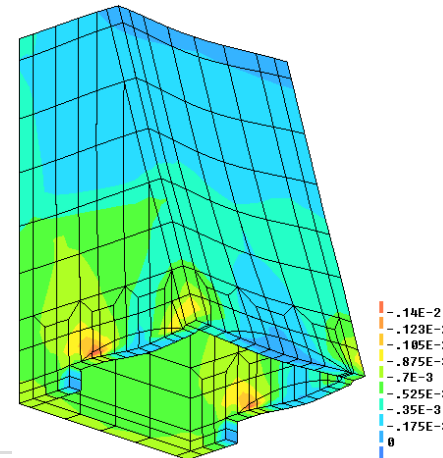
Crushing

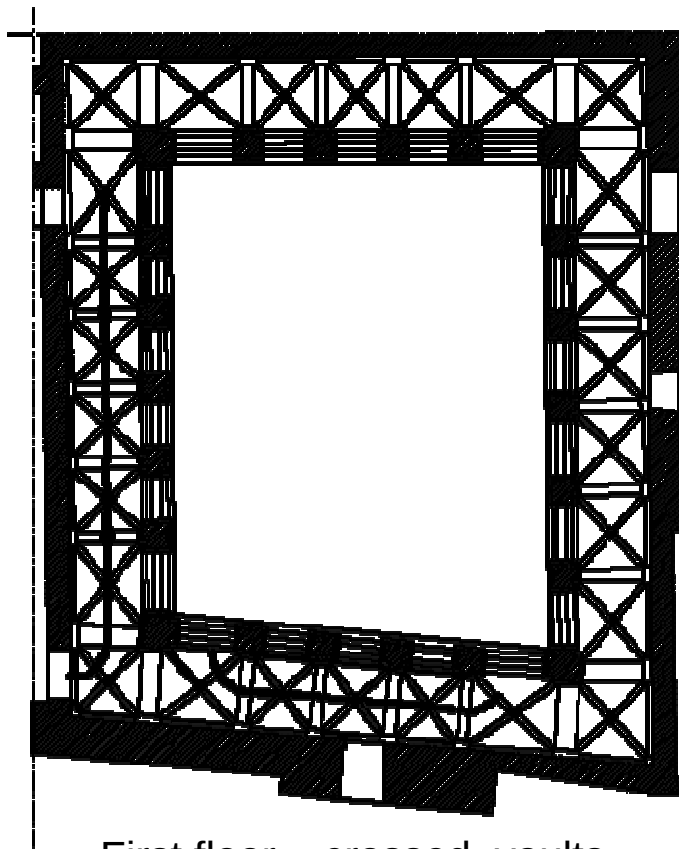
First floor – crossed vaults

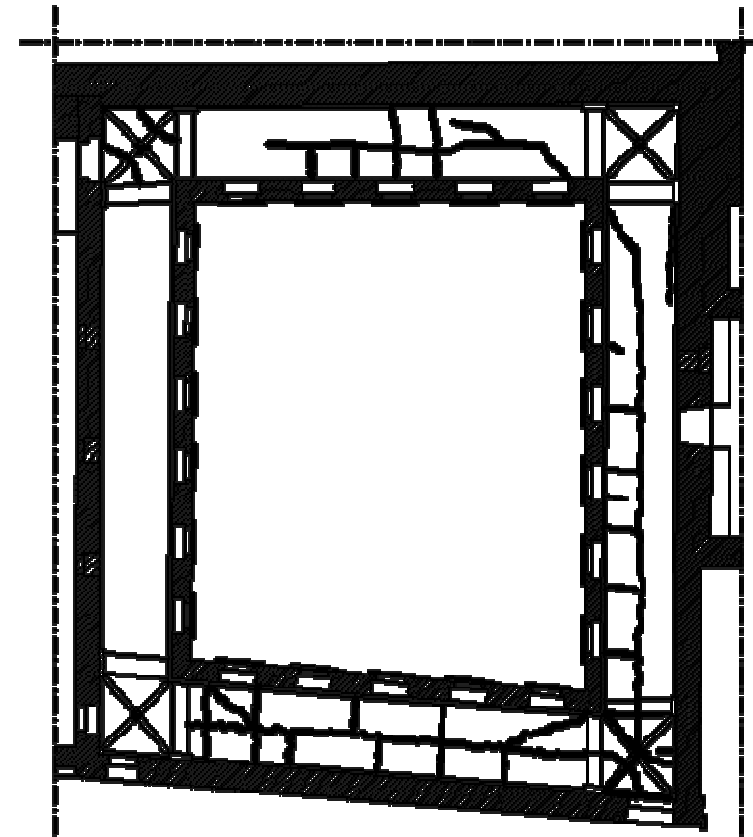
Second floor – barrel vaults

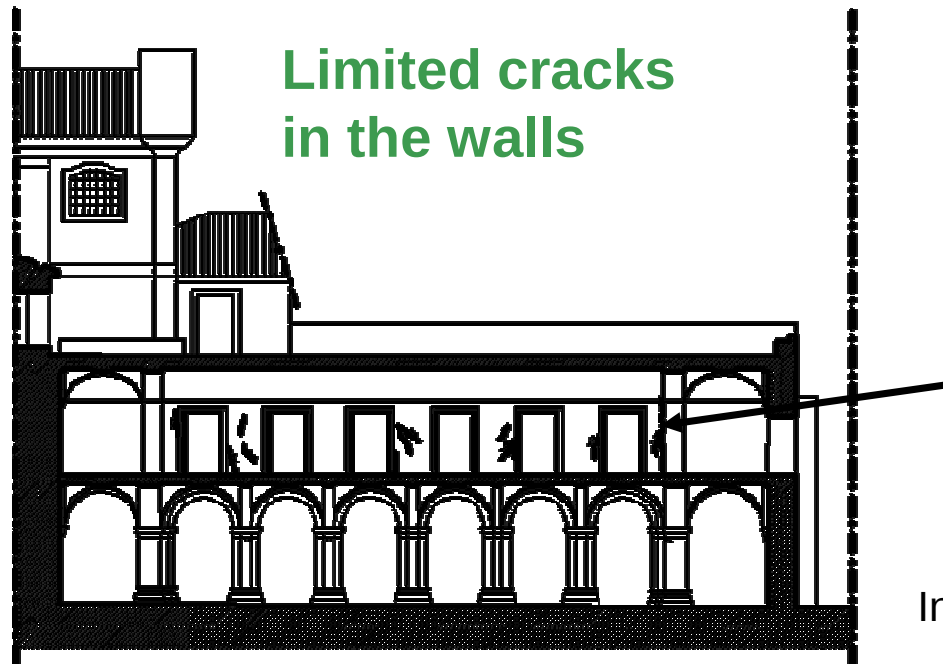
Limited cracks  
in the walls

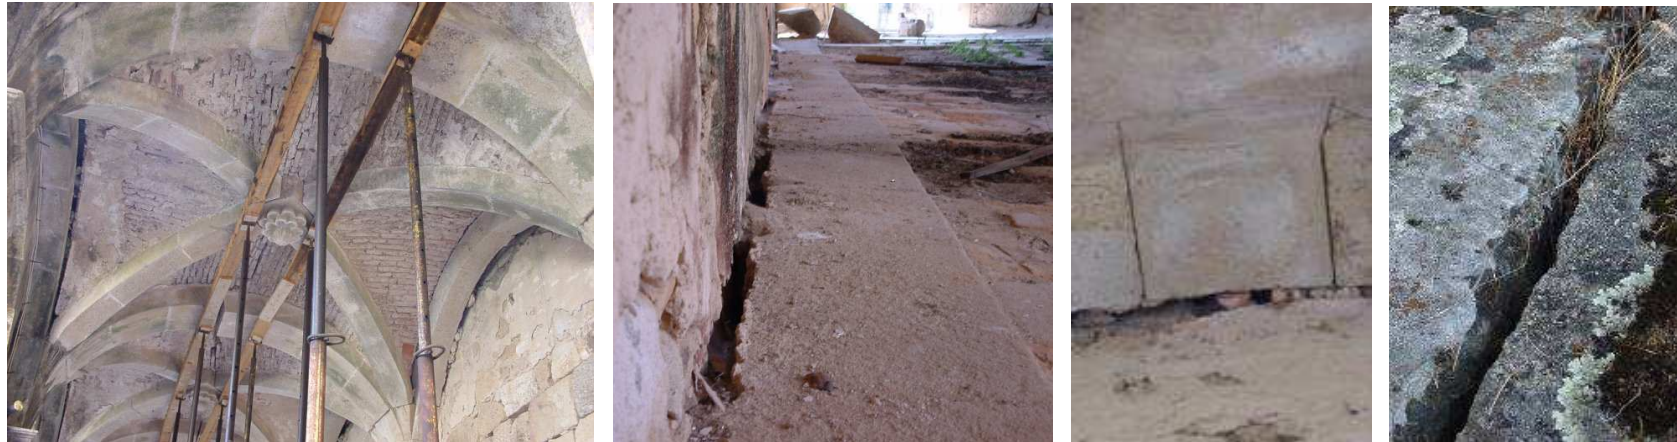
Separation between vaults and walls

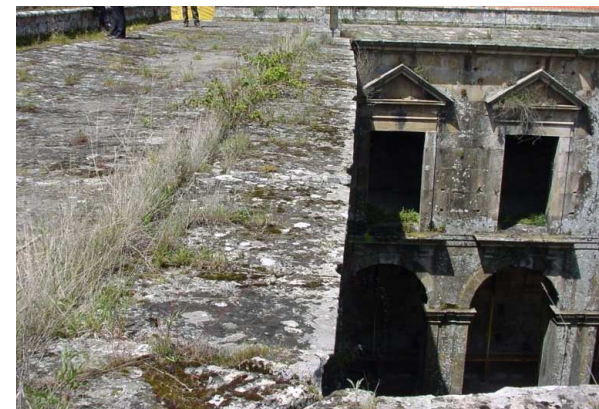
Out of plumbness of walls (2<sup>nd</sup> level). Resulted in vertical displacements in vaults' extrados up to 0.10 m

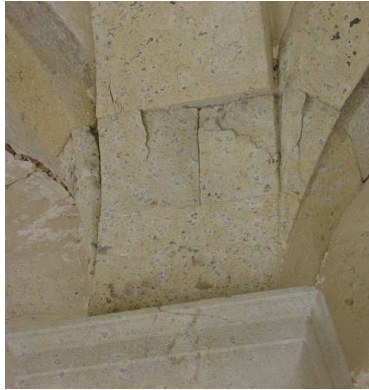
Crushing / shearing of brackets

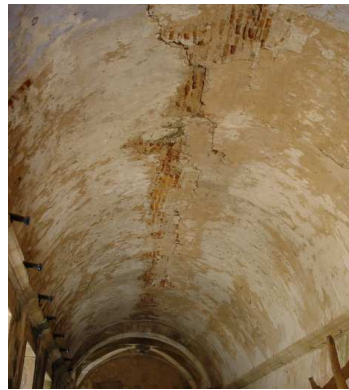
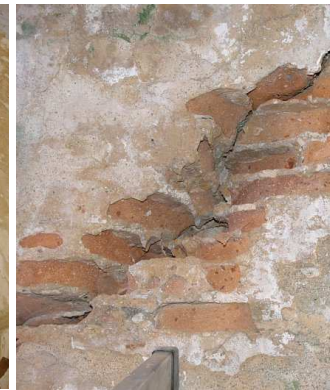
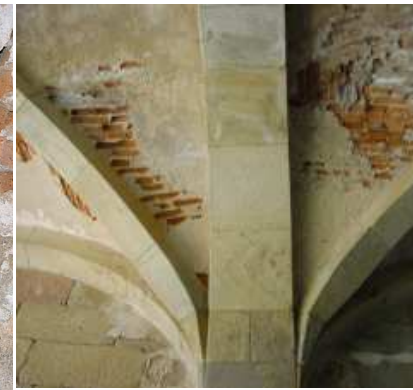
Deterioration of bricks

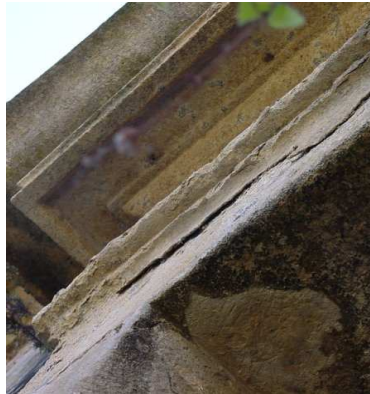
Stone deterioration

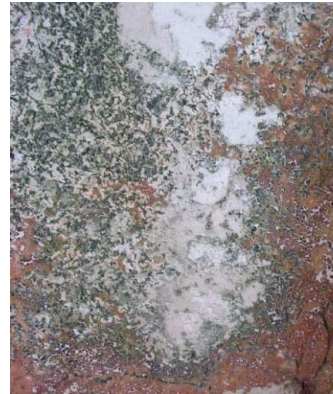
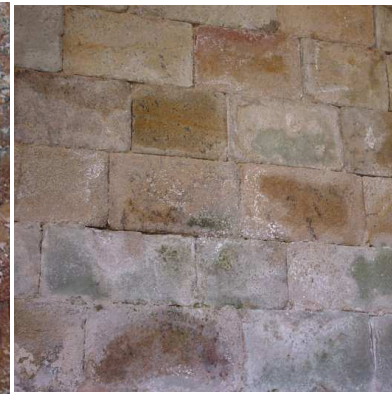
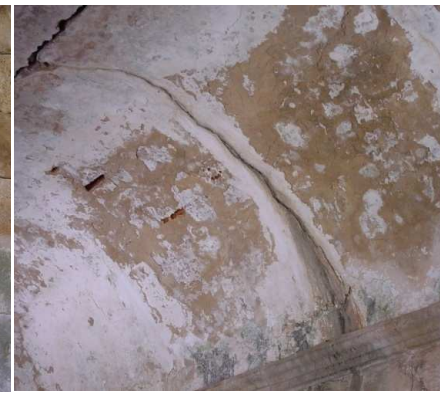
Biological colonization and moisture stains

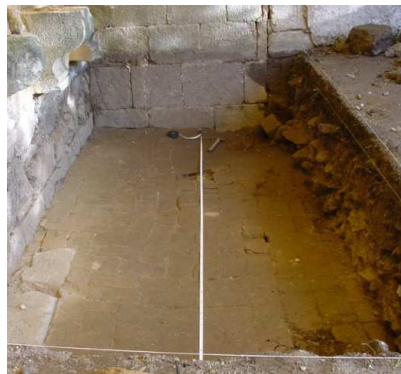
Aspect of  
wall  
foundations

Soil foundation exhibits moderate resistance and very large heterogeneity for depths between 1.0 and 1.8 m

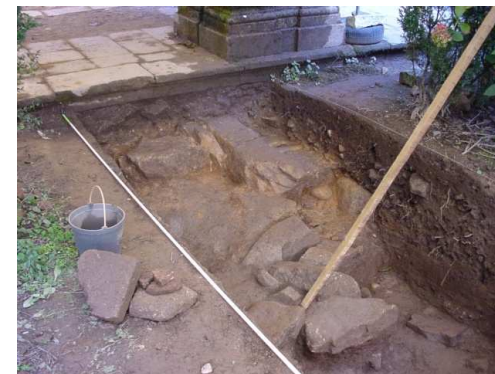
Aspect of  
column  
foundations

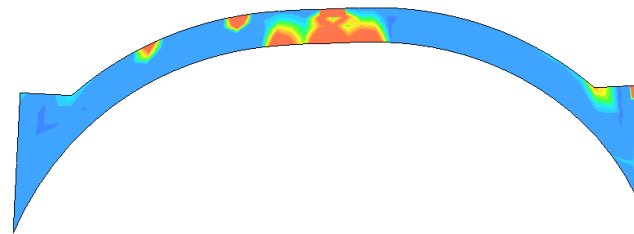
Damage in the barrel vault

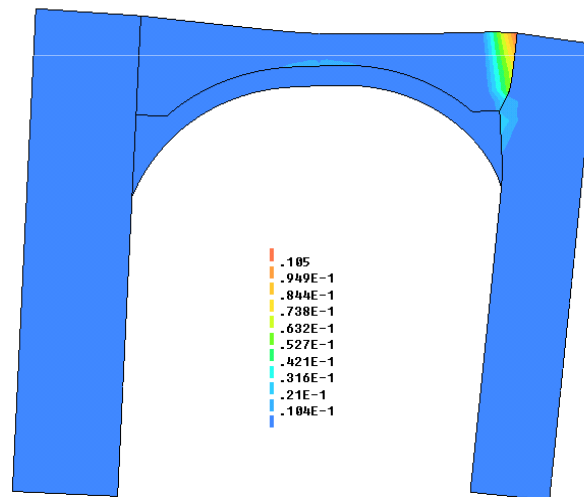
Damage in all the entire structure

- Foundations and long term behaviour of the structure are mostly responsible for observed damage
- Strengthening is needed

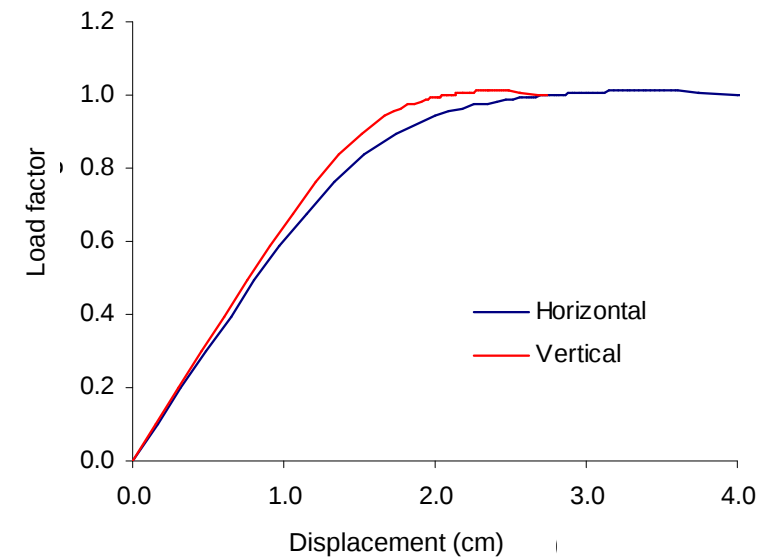
Relation between the load factor and the displacements exhibited by the structure ("zero safety level")
