# Engineering Applications

# Chimney in Arouca

# Monastery of Salzedas (Portugal): Intervention in the cloister

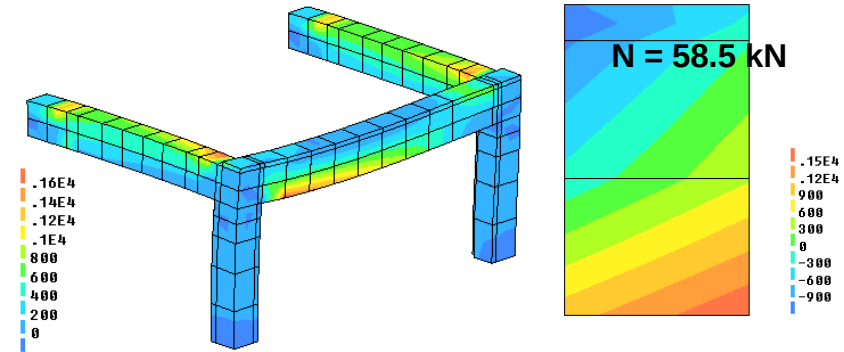
Elastic results with arching action:

$$\sigma_{t,\max} = 3.5 \text{ N/mm}^2$$

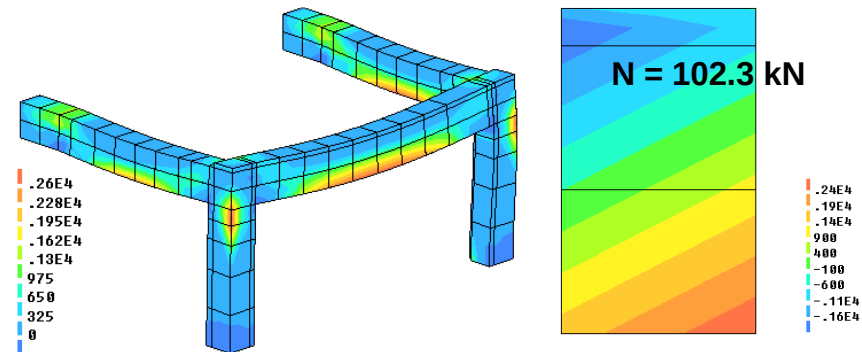
Elastic results without arching action:

$$\sigma_{t,\max} = 6.2 \text{ N/mm}^2$$

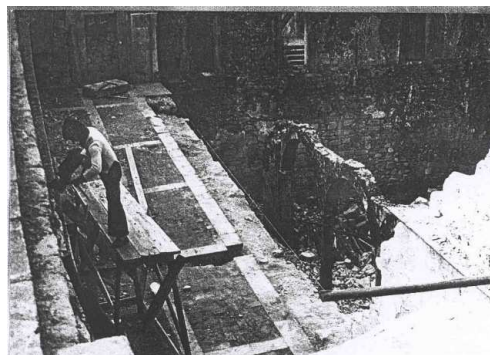
Dismantling and reassembly of the wall between the small and the large cloisters

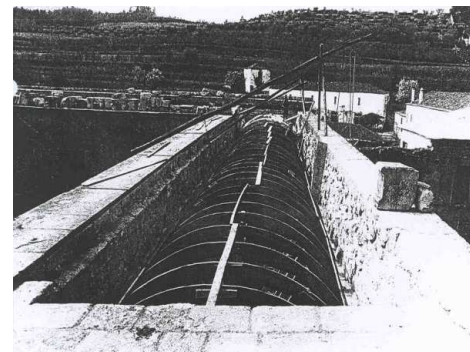
Replacement of the barrel vault of the West wing

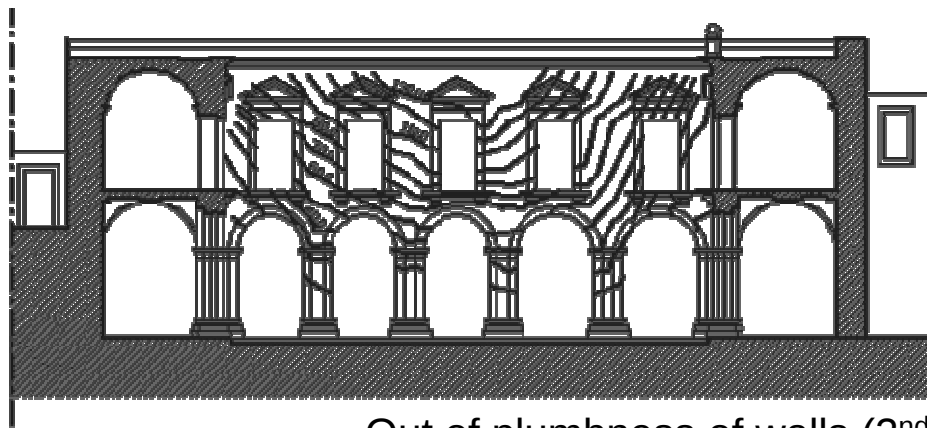
Separation between vaults and walls

Out of plumbness of walls (2<sup>nd</sup> level). Resulted in vertical displacements in vaults' extrados up to 0.10 m

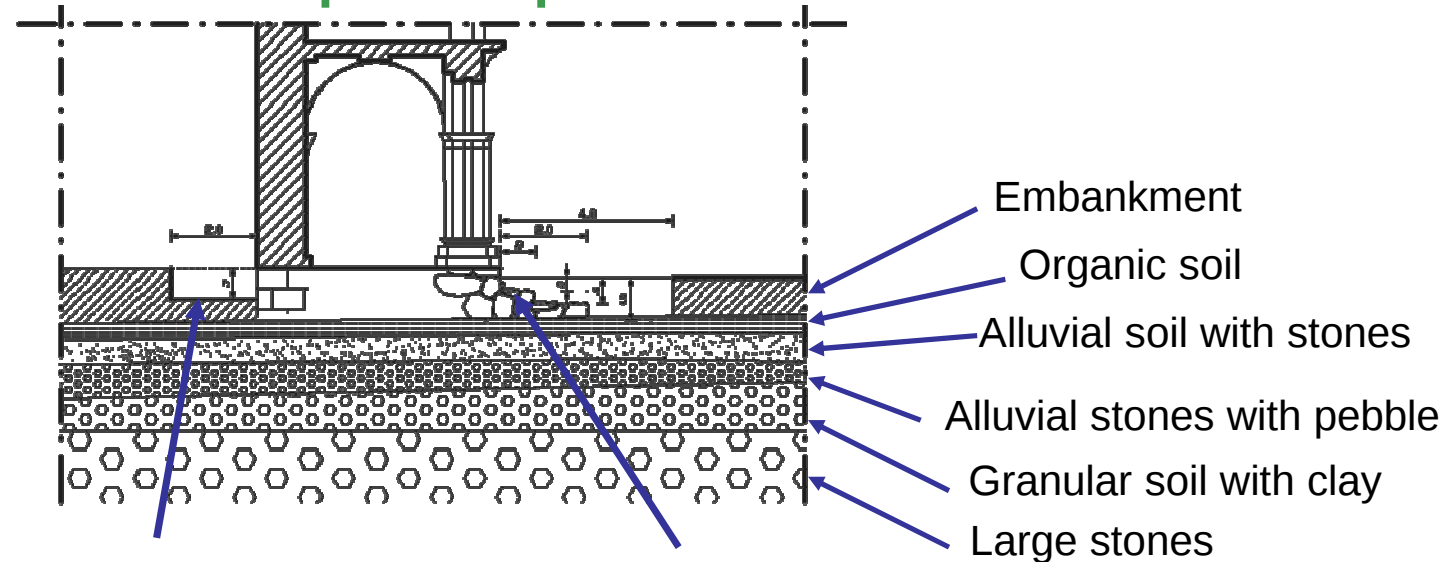
## Foundation inspection pits

Aspect of  
wall  
foundations

Soil foundation exhibits moderate resistance and very large heterogeneity for depths between 1.0 and 1.8 m

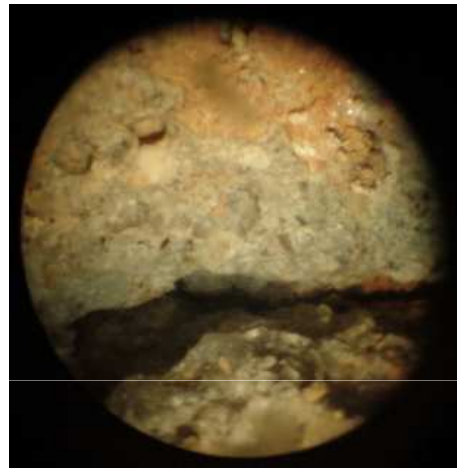
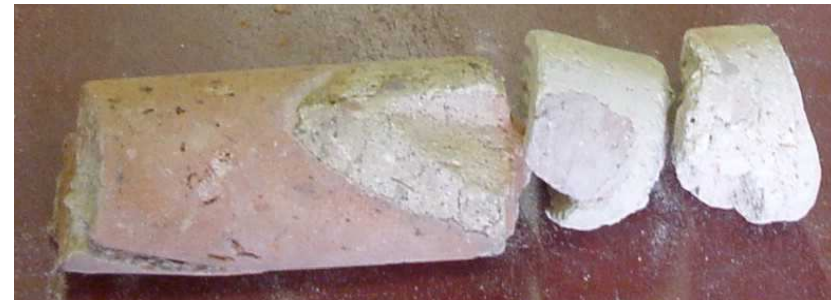
## Tests on walls and vaults (I)

The vaults are built with clay brick masonry with 0.22m thickness and infill (soil in 1<sup>st</sup> level and lime “concrete” in the 2<sup>nd</sup> level)

The walls are built with large granite stones, mostly with clay mortared joints

Internal longitudinal cracks or voids were not found

Low strength and high porosity bricks (compressive strength 5 N/mm<sup>2</sup>)

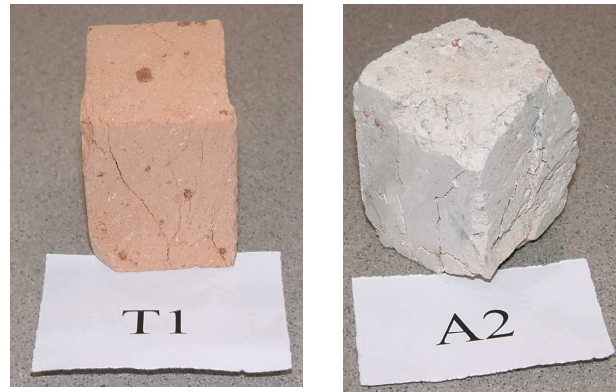
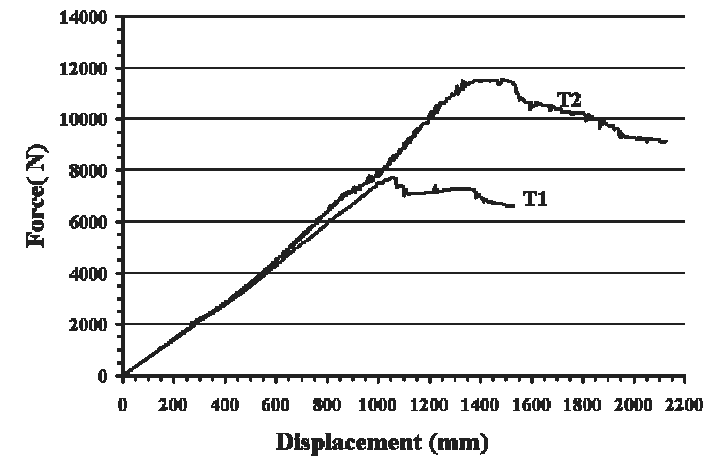
## Tests on walls and vaults (II)

Samples for the uniaxial compression tests

$$E_b = 7.3 \text{ GPa} \quad f_b = 5.2 \text{ MPa}$$

$$E_m = 8.6 \text{ GPa} \quad f_m = 3.8 \text{ MPa}$$

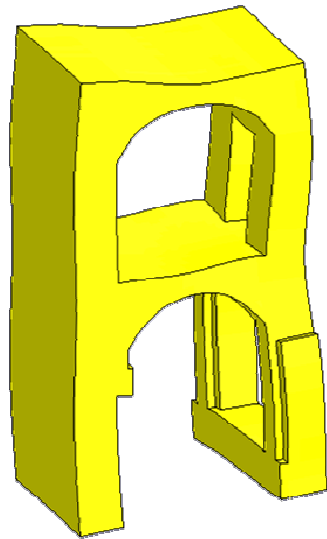
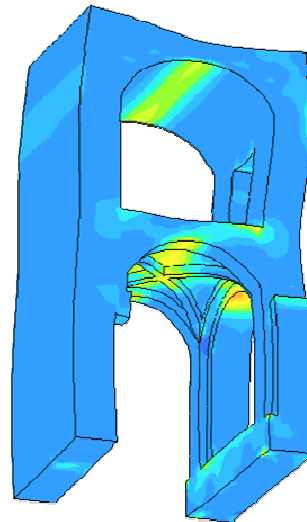
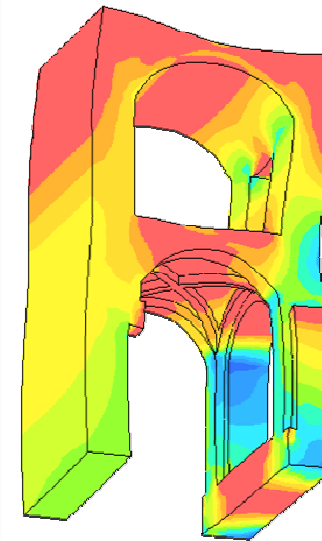
## Structural analysis (Linear Elastic)

Deformation of the structure

Maximum principal stresses

Minimal principal stresses

- The large horizontal displacements observed in the structure can only be explained by a geometrical and physical non-linear analysis
- The 3D model served also for validation of a simplified 2D model (only of the 2<sup>nd</sup> floor)
- The structure presents original conceptual deficiencies (insufficient buttressing in internal walls)

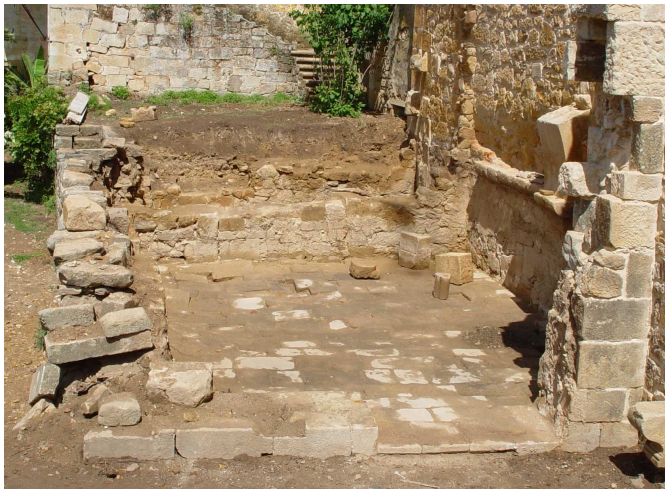
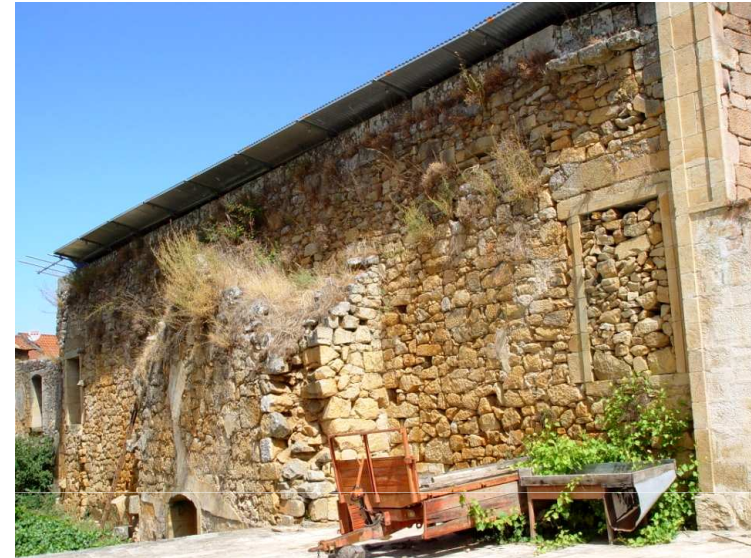
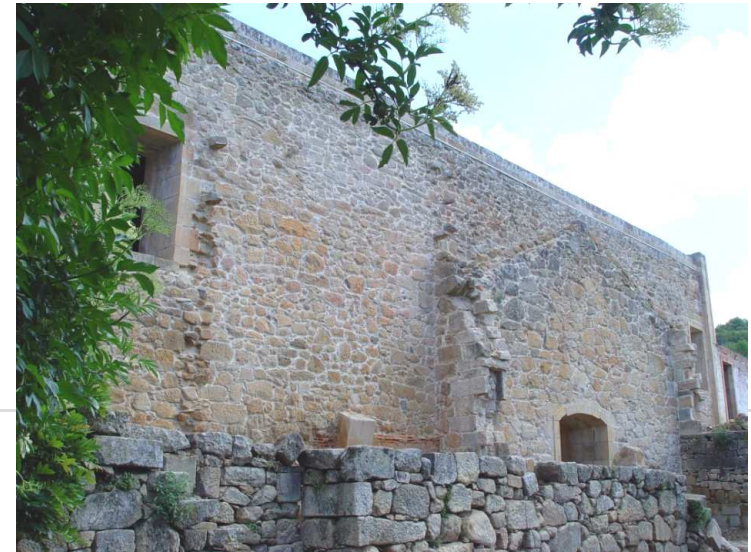
## Completed South wall

Before

After
